Contractor	All Sealants, Inc.	Surveyed by	Jeff Schoettle
Date	8/22/2023 11:27 AM	Foremen	Steve Collaro
Project	Six Corners		4800 W Irving Park Rd Chicago,IL
Site Conditions			
Site Activity	Priming/ coating		
Notes

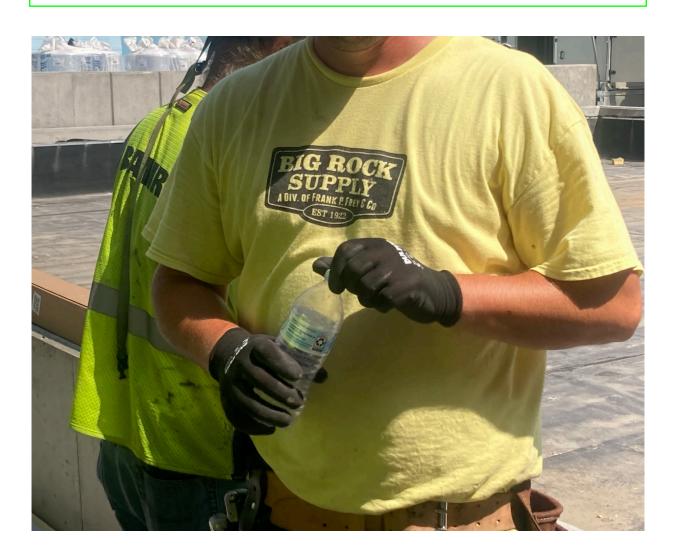
Conditions are hot; water is available on the roof; discussed regular water intake and resting in a shaded area

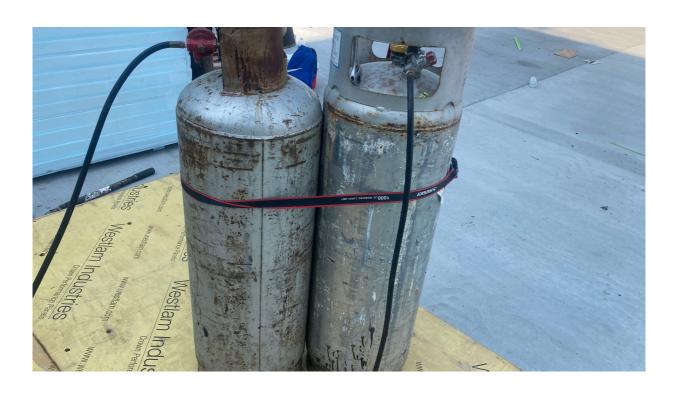
Compressed gas cylinders are secured to prevent displacement

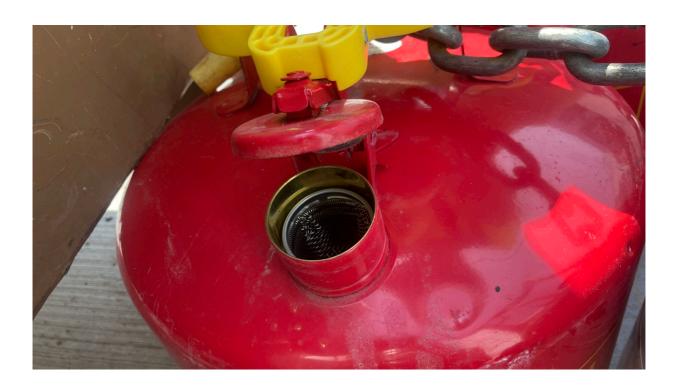
Safety can for flammable liquids is equipped with a flame arrestor

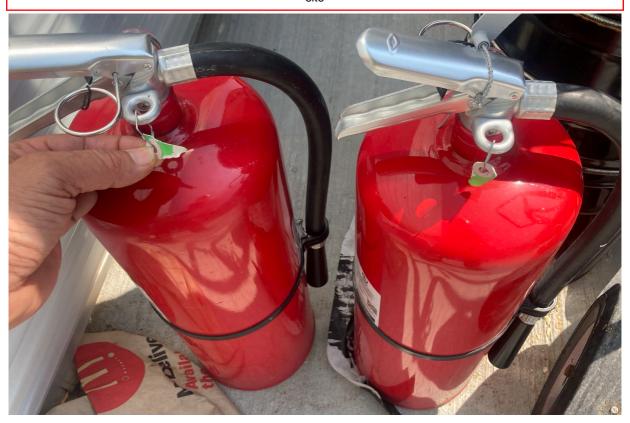
Fire extinguisher inspection should be conducted annually. Inspection tags missing from all 3 fire extinguishers on site

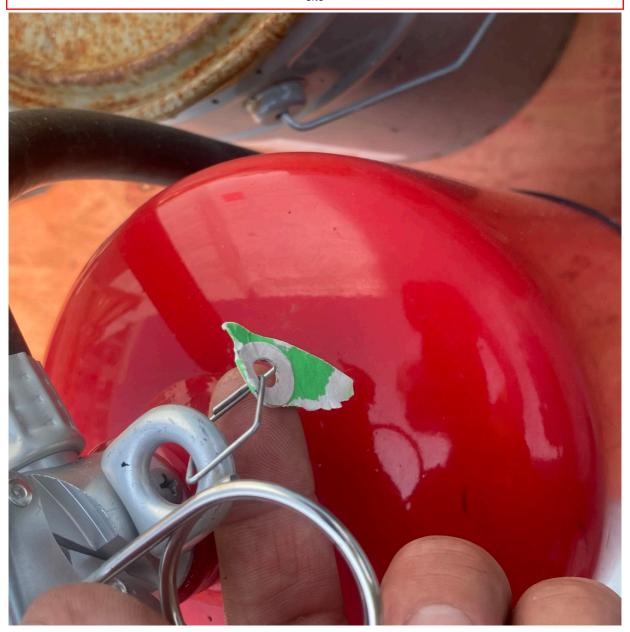
Fire extinguisher inspection should be conducted annually. Inspection tags missing from all 3 fire extinguishers on site
